**SITE ASSESSMENT**  
**FOR**  
**PARSONS CHEMICAL WORKS**  
**GRAND LEDGE, MICHIGAN**

**Prepared for:**  
**U.S. Environmental Protection Agency**  
**Region V**  
**230 South Dearborn Street**  
**Chicago, Illinois**

**September 1988**

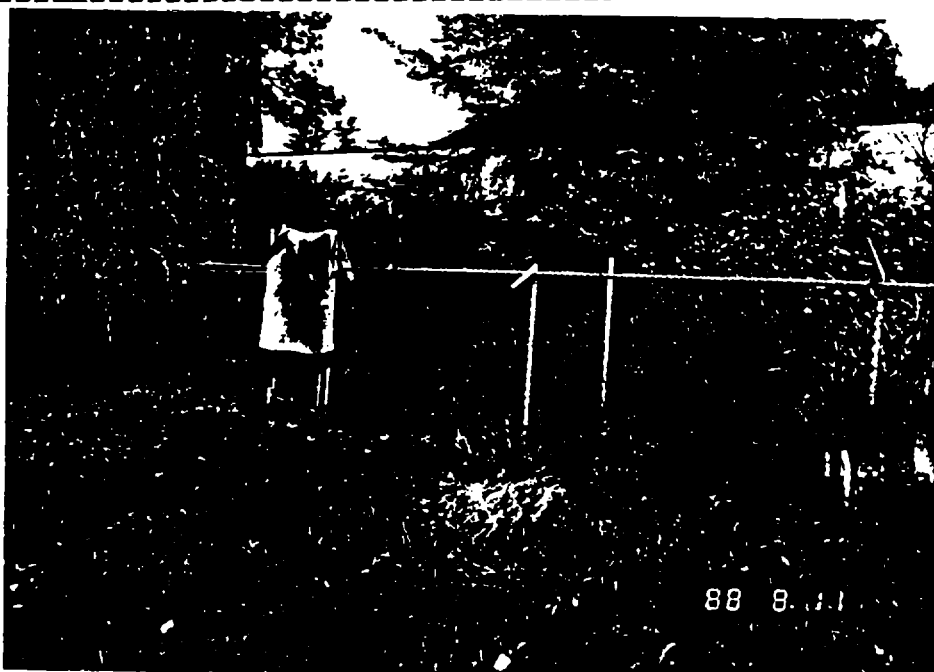
PHOTOGRAPH NUMBER: eight

SUBJECT: Tarp over warning sign and damaged barbed wire fence.

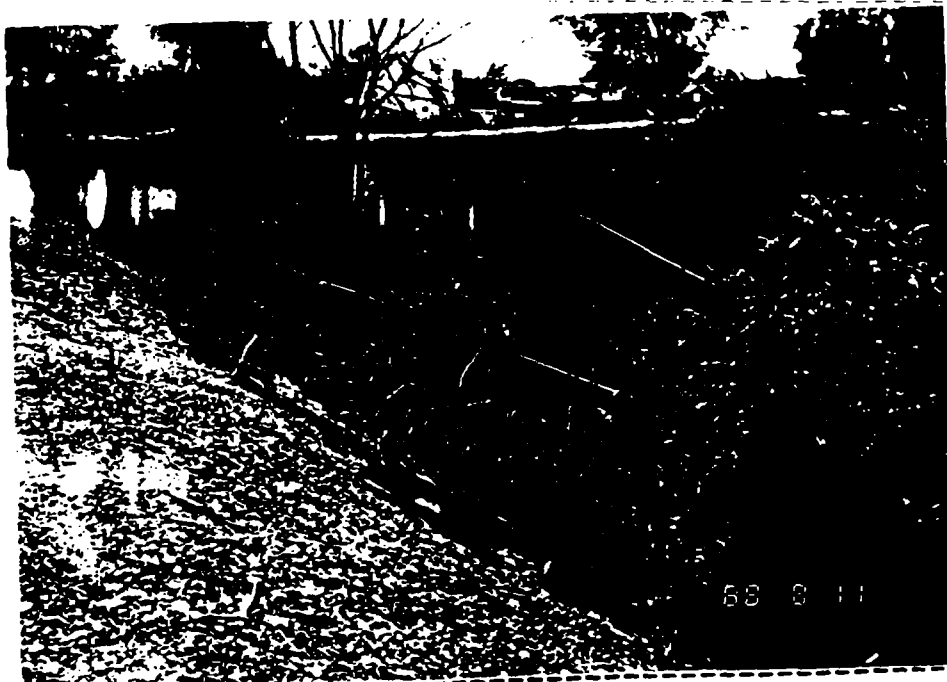
PHOTOGRAPH NUMBER: ten

SUBJECT: Looking down from railroad tracks into area #2 showing dead trees and erosional surface.

No dioxin has been documented where the drain leads to the unnamed stream (fence area #2). Therefore, the TAT recommends replacing the collapsed drain in this area with suitable concrete pipe or an above ground concrete trough leading to the stream. This would prevent further erosion and potential contaminant migration. The fence should remain permanently surrounding this area.
